Mechanical Assistance Equipment Test and Evaluation Program

Volume 7 – Equipment Evaluation (Omega 5 Aegis Mini-Flail)

Technical Report

DRES TR 2001-078

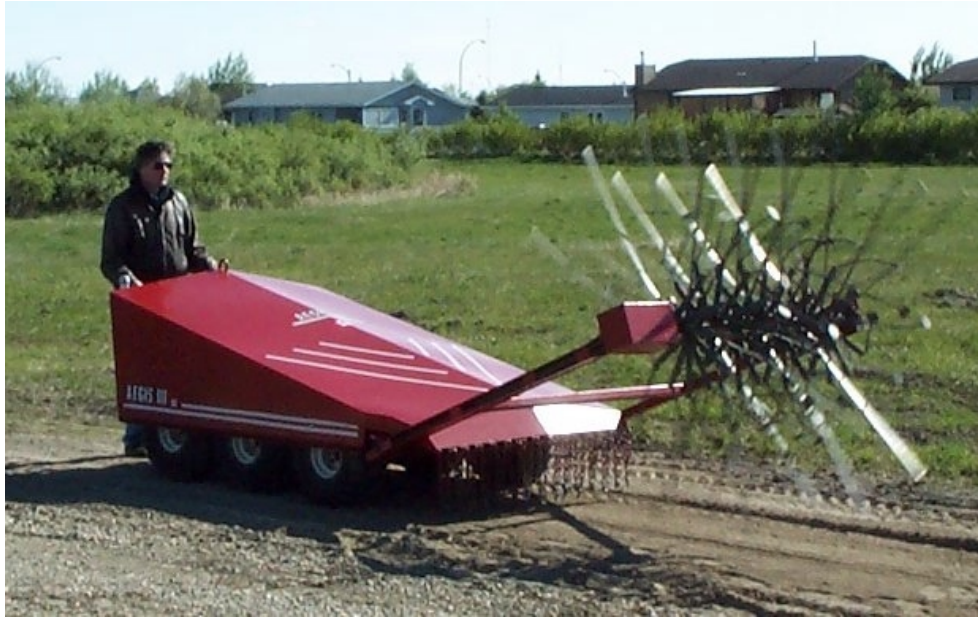
Figure 1. Omega 5 “Aegis” Mini-Flail

The Omega 5 Aegis mini flail was described as a remotely controlled vehicle with a novel front mounted “slapper” type flail. The intent was that the slapping elements would slap the mine pressure plate or the ground surface. The load would transfer through the soil to buried mines and activate the fuzes. In addition the flail head was equipped with short chains attached to small steel disks which would be used for light bush cutting.

The vehicle portion was a 6 wheeled, hydraulically driven chassis under a wedge shaped cover. The hydraulic drive system was powered by a small portable engine (approximately 10 hp). A second engine of about the same size was used to power the flail hydraulics. The vehicle was fitted with a radio remote control system. Backup manual control was via toggle switches mounted on the rear of the vehicle.

One of the four candidate machines selected for the CCMAT MAE T&E program was the Aegis mini-flail (see Figure 1) from Omega 5 in Ontario. Unlike larger military flails, a small, remotely controlled flail might find use in more confined areas and in situations where the cost, size or support requirements of the larger units cannot be justified. Furthermore, this particular design of flail head presented some innovations relative to existing flails.

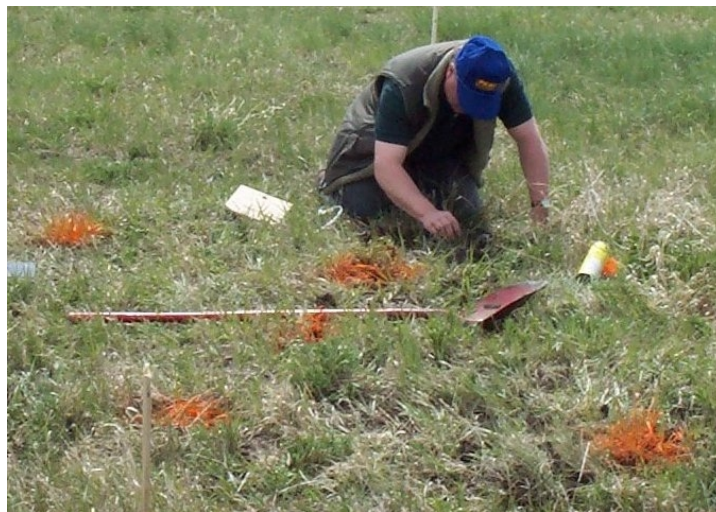
Figure 2. Placement and Marking of MRMs for Phase 1 Testing

Test patches were laid out in each soil/environment for each machine. In each test patch MRMs were buried at depths ranging from 0mm (“flush” buried) to 200mm. The machines were then allowed to operate on each test patch in whatever manner (within certain limitations) seemed most appropriate to the manufacturer. Following each “operation” by the machine, the MRMs were checked to determine the effectiveness of that operation, and a decision was made whether to repeat the operation or to declare that test patch “finished.”

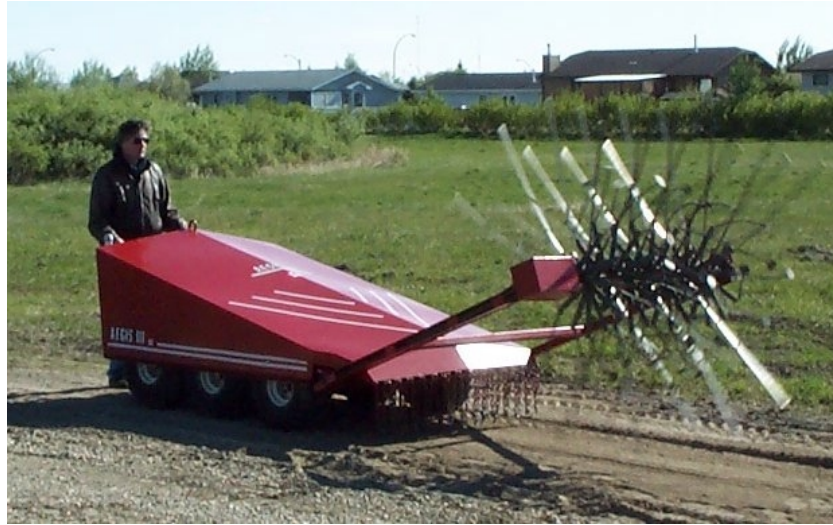
Figure 4. *Omega 5 Aegis Flail Under Manual Control*

- The remote control system did not operate properly. While not a necessary part of the system for the purposes of either the preliminary trials or the detailed trials, it did present problems with respect to conducting the trials. As shown in Figure 4, manual operation of the Aegis required the operator to walk behind the machine. This placed the operator directly in the path of any thrown debris (a safety hazard), and also would require the operator to walk inside the test lanes (compromising the MRM data) during the DRES testing. A simple remote control umbilical cable allowing the operator to walk alongside the machine would have been more suitable.

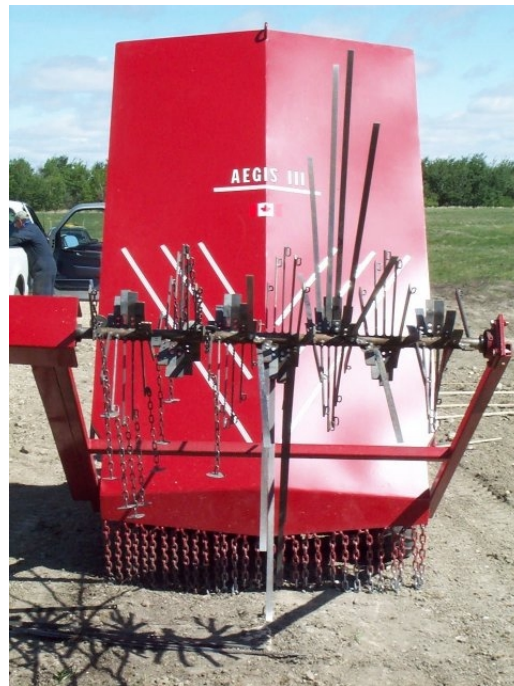
Figure 8. *Omega 5 Aegis Mini-Flail With Most Slappers and Cutters Removed*

- Repeated attempts to engage more mines failed even when most of the slapper attachments had been removed to put more power into the ground (i.e.: more horsepower per unit width of flail head.) Ultimately the last of the slapper attachments were removed and the chain/disk brush cutting attachments were tried against the remaining mines with no additional mines being triggered. Figure 8 and Figure 9 show these last two configurations.

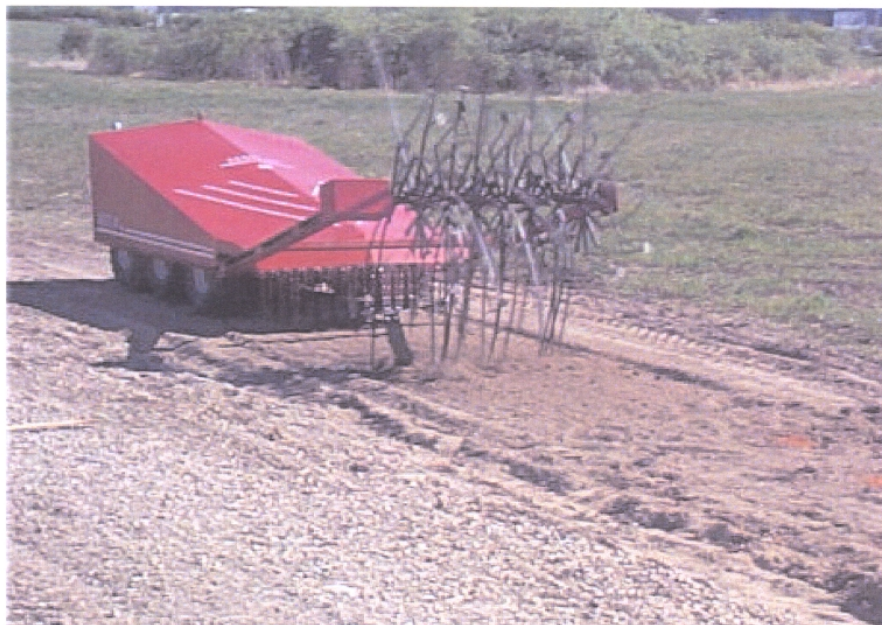
Figure 1. Omega 5 Flail Demining Implement.

The Omega 5 consists of a six-wheeled propulsion vehicle with a tool frame extending in front of the vehicle as shown in **Figure 1**. The tool frame holds a 1.22 m wide shaft that flail attachments are connected to. There are two spiral rows of attachment anchors. One set of 49 has 280 mm long rigid arms to which "chain and hammer flails" are connected. The other row has 47, 120 mm arms, which flexible steel straps are attached to. The shaft is powered by a hydraulic motor. The vehicle has two gasoline engines (8 hp and 10 hp). One engine powers the vehicle propulsion system; the other powers the flail and lift hydraulics. The vehicle has a remote control operating system.

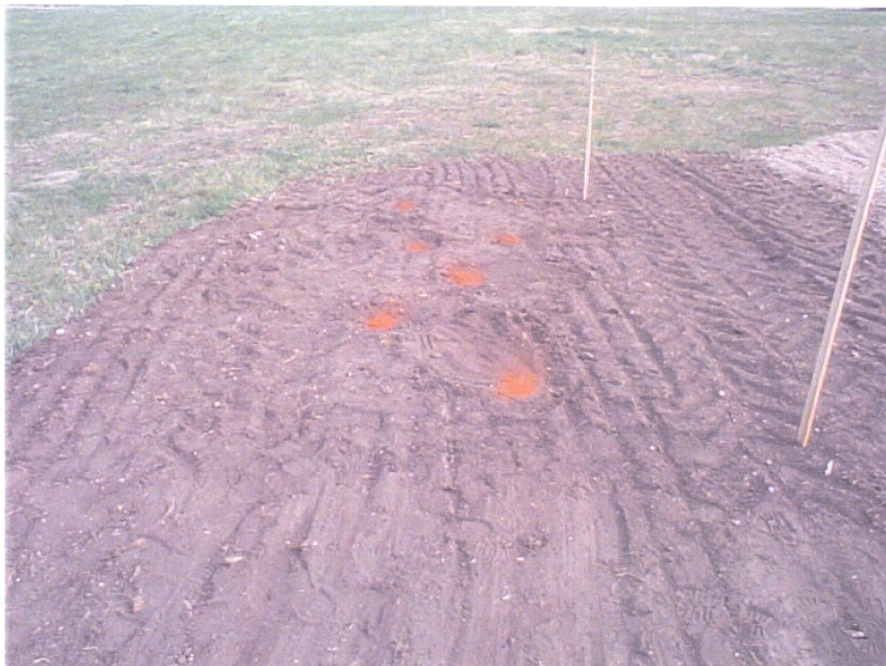
Figure 2. Mine Location Marked.

Each plot had six surrogate mines buried at random depths of 50, 100, 150 or 200 mm or level with the surface. In the plots, the mine locations were marked with orange paint, to make their location visible to the operator as shown in **Figure 2**.

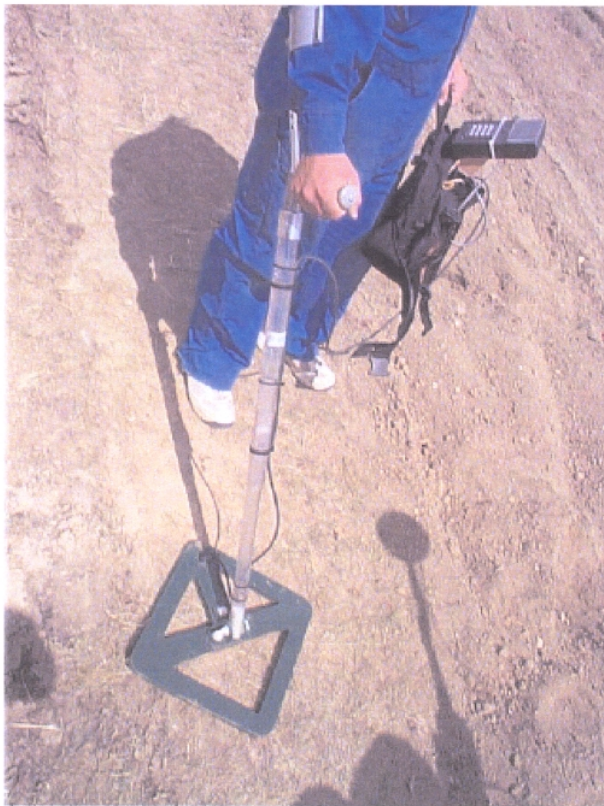
Figure 3. DRES Surrogate Mine Detector.

Prior to processing, the mines were interrogated using the DRES "surrogate mine detector" as shown in **Figure 3**, to ensure that they were functional immediately prior to testing.

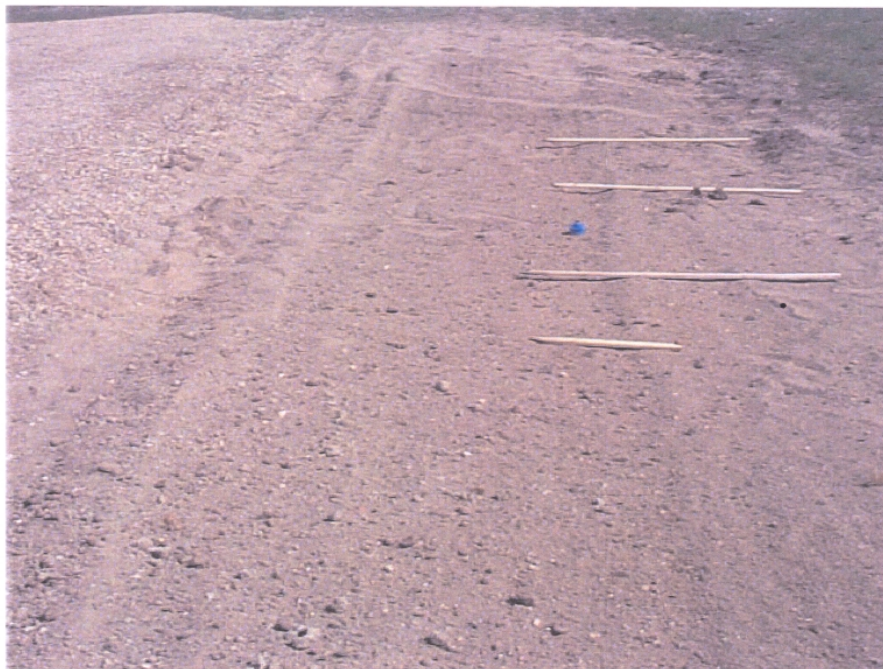
Figure 4. Ground Processed by Omega 5.

The Omega 5 was operated in the sand plot. Due to mechanical problems, the machine could not drive the flail with enough force to slap the flails against the ground. The flail had to be raised until only the tips contacted the ground. This caused the flails to appear to "dance" over the ground leaving a pitted appearance as shown in **Figure 4**.

After four passes across the sand plot there was little evidence that the Omega 5 would have any chance of neutralizing any mines below the surface. One mine located at the surface was deactivated and another one was rolled onto the surface. It was noticed that with the Omega 5 turning forward, as intended, any surface mines that were uprooted would be thrown under the machine. The Omega 5 was run backwards which solved the problem of throwing the mines under the vehicle.
