Mechanical Assistance Equipment Test and Evaluation Program

Volume 8 – Equipment Evaluation (Miscellaneous Equipment)

Technical Report

DRES TR 2001-078

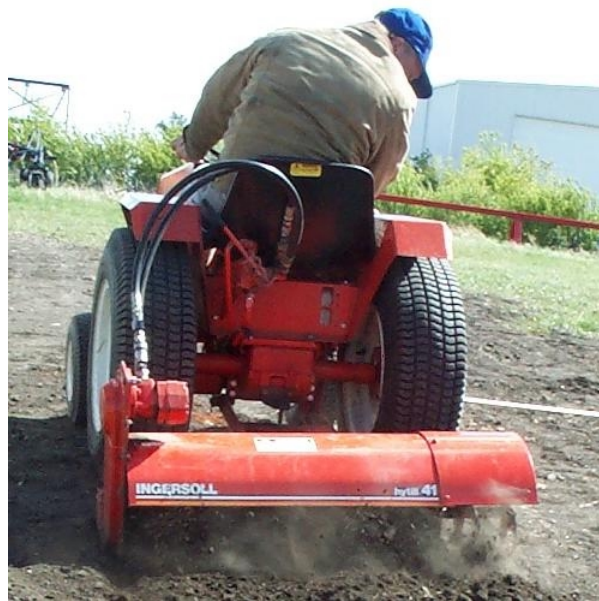
Figure 1. Garden Tractor Rototiller

The machine in question was a 25 year old, 18hp, hydrostatic drive Case tractor with a 42” (1.07m) rototiller. While it was originally rated at 18hp, this was an ageing machine and it was probably no longer capable of that power output. In addition, the

During a lull in the phase 1 testing at PAMI, an older model garden tractor with a rear mounted rototiller was observed (see Figure 1). With the testing of the Omega 5 Aegis mini-flail having just been aborted (see Volume 7 of this report), there were several MRMs in the ground that needed to be recovered. Rather than dig them up by hand, it was decided to use the rototiller. This would serve the dual purposes of recovering the buried MRMs, and of examining the potential of such a device for humanitarian demining service. This was not intended to be a formal test, nor a detailed investigation.

rototiller attachment was well used, and therefore probably not capable of peak performance. Nevertheless, this was a purely qualitative, “proof of concept” test, and the equipment was considered perfectly adequate for the task.

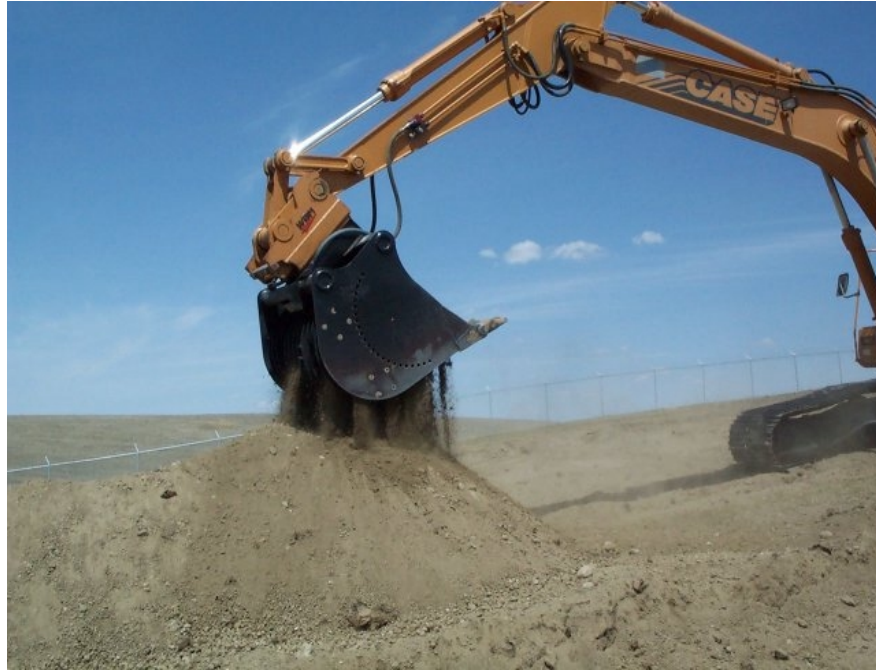
Terra Firm, the supplier of the Case 9040B track-hoe used with the ProMac BDM48, was contracted to provide a Vibra-Ram Wack VRL-8 sorting bucket, shown in Figure 2 and Figure 3. This sorting bucket, superficially similar in appearance to a conventional digging bucket, used a hydraulic motor to vibrate a clotted cage. This cage, suspended on rubber mounts between the two side plate of the bucket would capture larger pieces while letting small pieces fall through. By fitting the cage with different sized screens, the size of the retained material could easily be adjusted.

Figure 2. Commercial VRL-8 Sorting Bucket

It is important to note that the VRL-8 sorting bucket is not suited to heavy or even “normal” digging. With the internal portion of the bucket replaced by the floating cage, any heavy digging could easily damage the rubber mounts or the structure of the cage. The VRL-8 should only be used for light duty digging, carefully done.

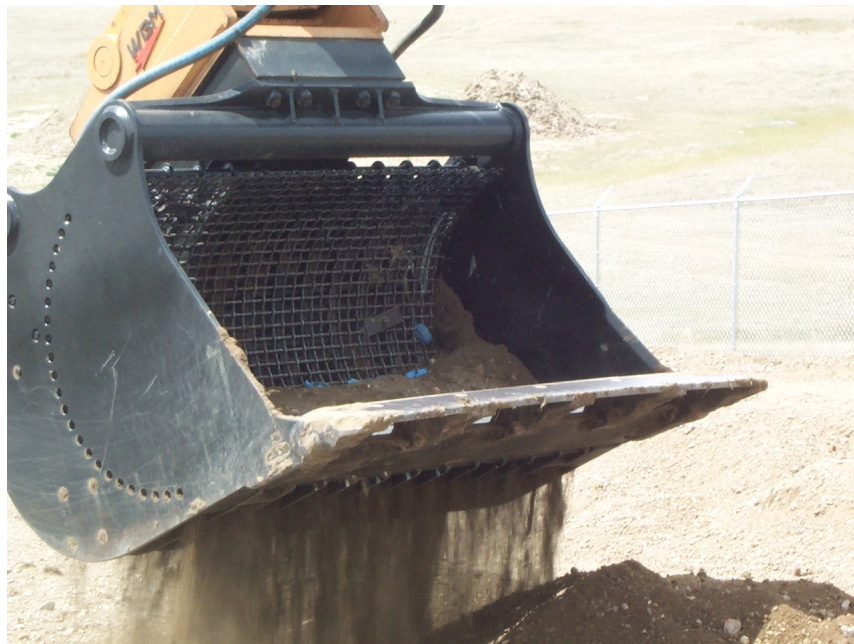
Figure 3. VRL-8 Sorting Bucket with Replaceable Screen

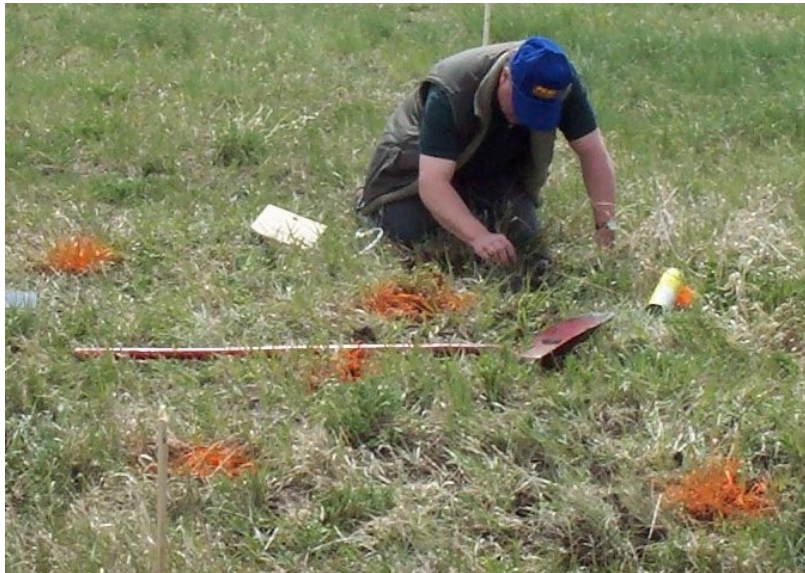
Test patches were laid out in each soil/environment for each machine. In each test patch MRMs were buried at depths ranging from 0mm (“flush” buried) to 200mm. The machines were then allowed to operate on each test patch in whatever manner (within certain limitations) seemed most appropriate to the manufacturer. Following each “operation” by the machine, the MRMs were checked to determine the effectiveness of that operation, and a decision was made whether to repeat the operation or to declare that test patch “finished.”

Figure 4. Placement and Marking of MRMs for Phase 1 Testing

Figure 4 and Figure 5 illustrate the placement and marking of the MRMs in this test phase.

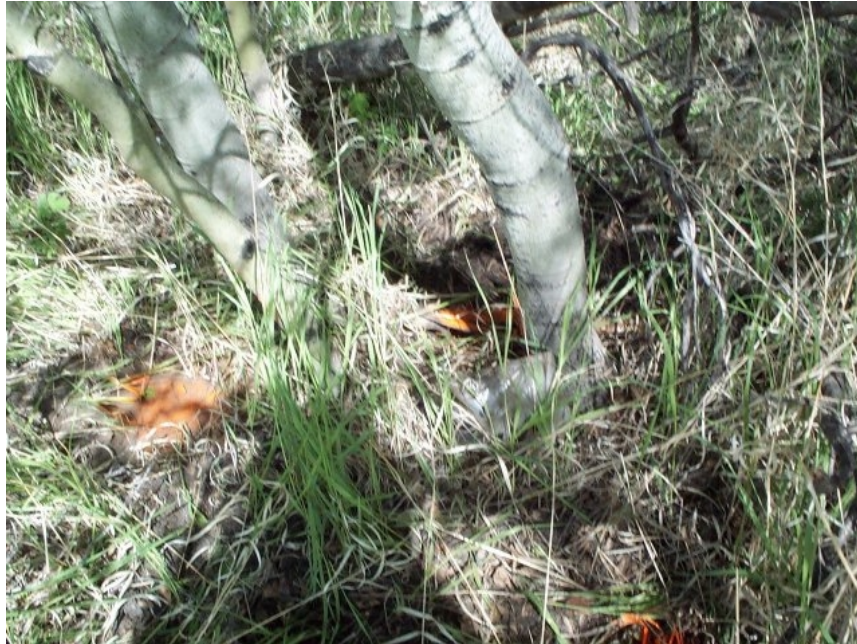
Figure 5. MRMs Were Located Around Trees And Roots In Poplar Grove

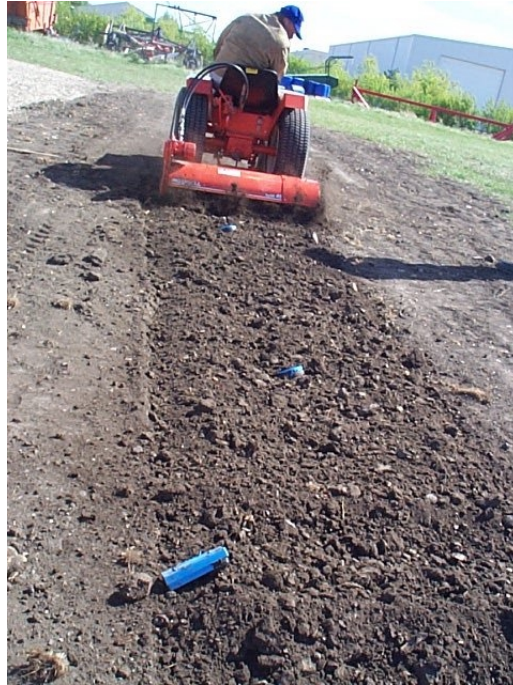
- The rototiller used in these tests was old and worn as was the tractor on which it was mounted. The tiller tines were too short to dig effectively beyond about 100mm, and certainly were too short to reach MRMs at 200mm. An MAE rototiller should have tines long enough to dig out MRMs/mines to 200mm DOB.
- As tested, the rototiller was under-powered. It had some difficulty digging through the prairie sod unless forward motion was very slow. Greater power to the tiller and better slow control of forward motion would be of great benefit.

Figure 6. *Garden Tractor Rototiller Bringing MRMs To The Surface*

As this was not part of the “official program,” detailed records were not made, nor were the tests conducted with the same rigour as used in preparing and conducting the tests for the “official” machines. Figure 6 through Figure 8 show the results described below.

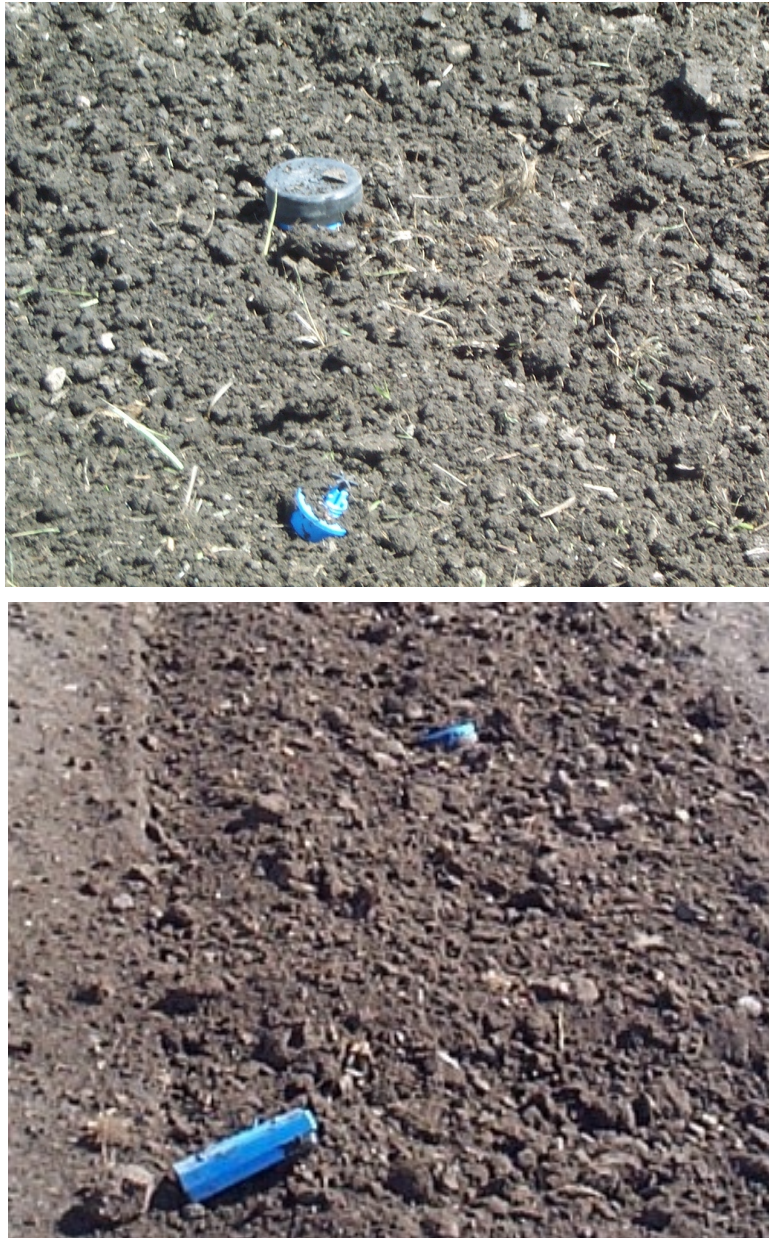
- In the sand test area there were three live MRMs with two buried at 100mm and the third at 25mm. Two of the three MRMs were brought to the surface with the rototiller, while the third was brought to within 5-10mm of the surface. They were not checked for their condition (live/dead).

- In the tilled black earth were 6 MRMs. Two were at 100mm DOB with one each at 0mm, 25mm, 50mm, and 200mm DOB. All were live before the test. On the first pass three MRMs were brought to the surface by the rototiller, and were removed by hand. Two remained live while the third had been triggered. On the second pass, the 200mm DOB MRM remained buried and live, while a PMA-2 was live and had been brought to the surface. This PMA-2 had lost its plunger and the top cover was partially removed. The last MRM had been triggered and was on the surface.

Figure 7. MRMs Brought to the Surface by the Rototiller

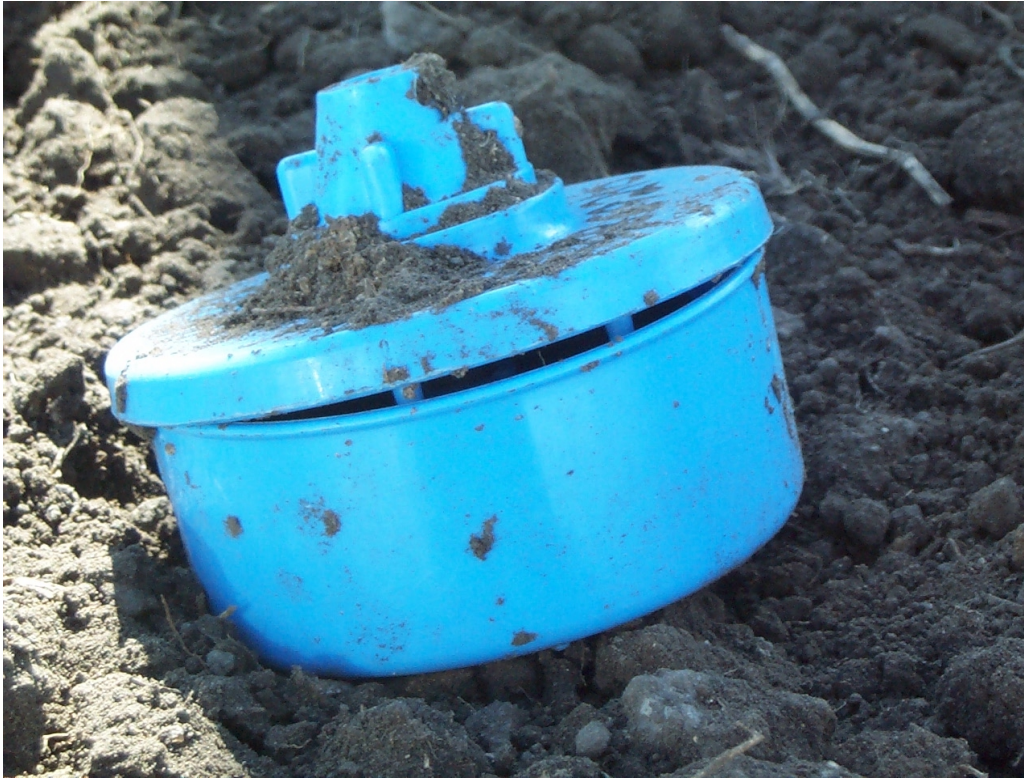
Figure 8. PMA-2 Plunger Removed and Lid Partially Removed By Rototiller

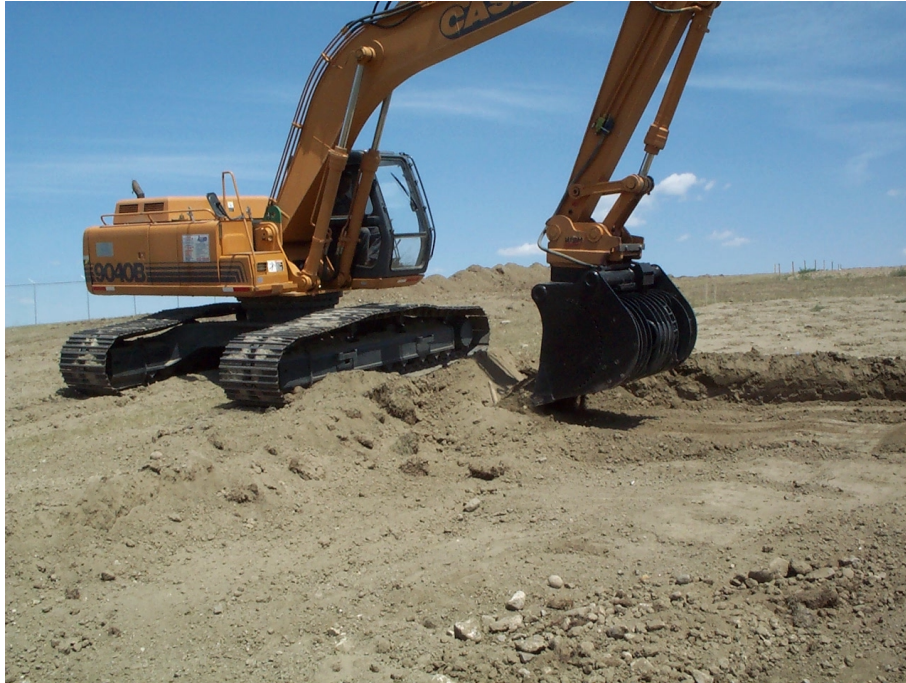
Figure 9. VRL-8 Alongside Test Frame in “MAE Mode”

The application of the VRL-8 as an MAE device may be limited by the soil conditions in many locations. While the soil conditions in this test frame were ideal, many minefields are in areas in which the ground is extremely hard during the summer or the dry season. As the VRL-8 is unsuited to heavy digging, this might make it unsuited to use during this period. In many of these places, the soil will soften considerably as a rainy season arrives, but this may result in soil too wet for the VRL-8 to handle effectively. Areas with softer soil but with heavy tree roots or very large boulders might also preclude the use of the “light-duty digging only” VRL-8. Specific environments would have to be evaluated carefully before applying the VRL-8 as an MAE device on its own. Figure 9 and Figure 10 show the system as tested in this program.

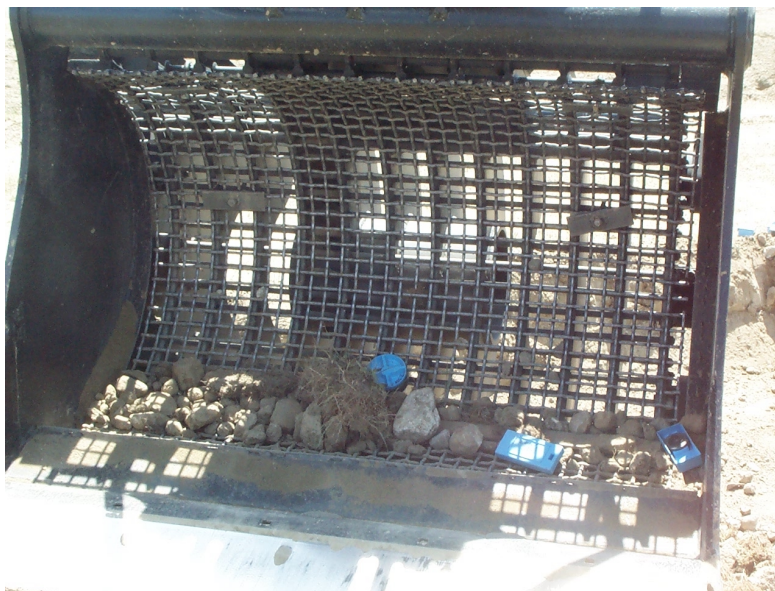
Figure 10. VRL-8 Extracting MRMs in “MAE Mode”

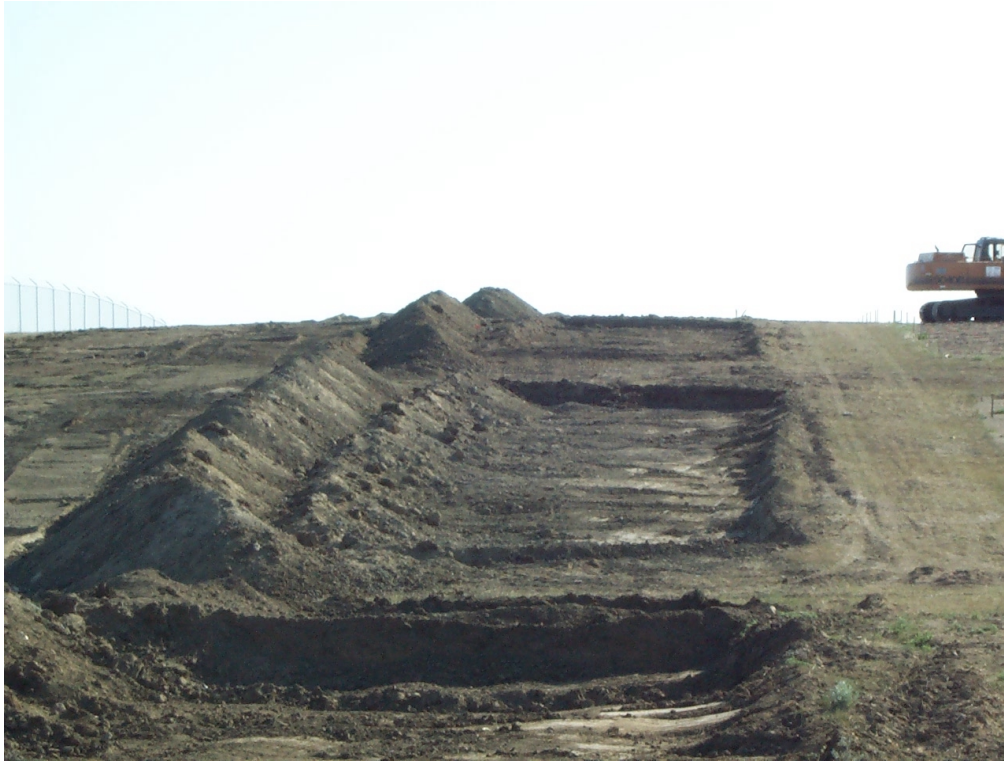
At the time that the VRL-8 sorting bucket was available, the other MAE candidate machines has finished testing. It was necessary at this point to recover any MRMs or large MRM fragments remaining in the ground. Given the good performance of the VRL-8 in sifting through the BDM48 berm, it was decided that the sorting bucket would be used to sift the MRMs and fragments from the soil through the rest of the test site. Results are seen in Figure 12.

Figure 12. Range Clearance By VRL-8 Sorting Bucket

This was not an activity that could be quantitatively measured. It was observed that the device operated at much the same speed and in the same manner described in paragraph 4.4.2.

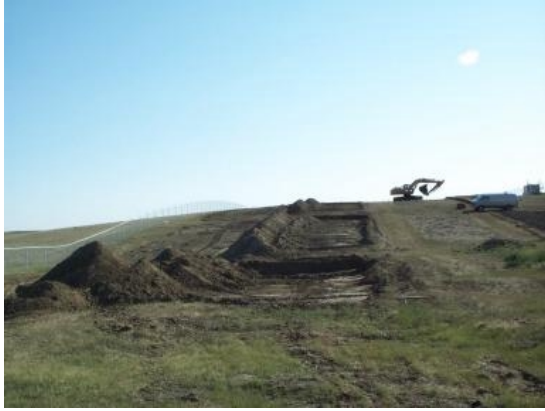
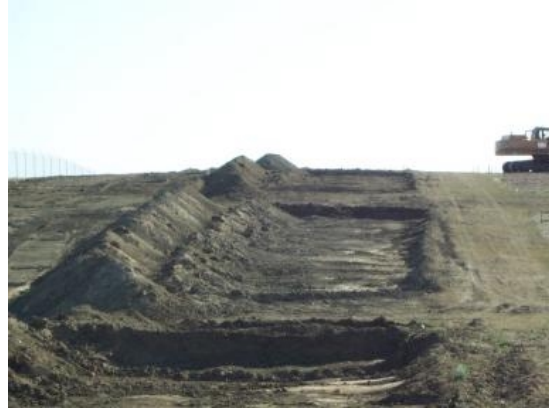
Figure A-13. VRL-8 Sorting Bucket
Range Clearance

Figure A-14. VRL-8 Sorting Bucket
Range Clearance

- Figure A-13 and Figure A-14 show the results of using the Vibra-Ram Wack VRL-8 Sorting Bucket in a range clearance role. The soil from the test areas has been sifted to remove MRMs and larger MRM fragments leaving the sifted soil and (potentially) small MRM fragments in the berm.
- The images shown in Figure A-15 through Figure A-20 show the testing of the VRL-8 sifting bucket as a possible MAE candidate in its own right.
- Figure A-21 through Figure A-26 shows images of the VRL-8 Sorting Bucket processing the berm left behind by the ProMac BDM48.

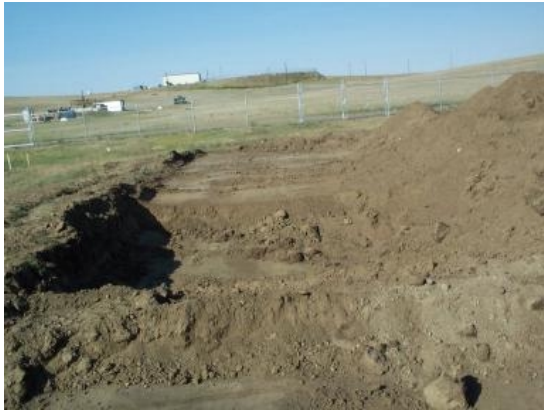
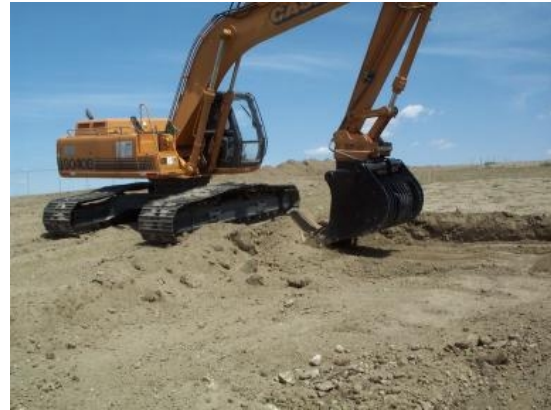
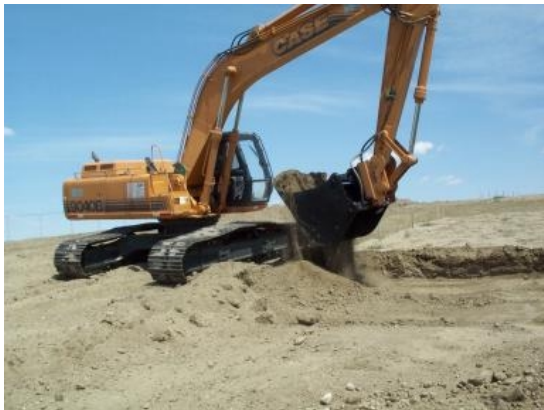
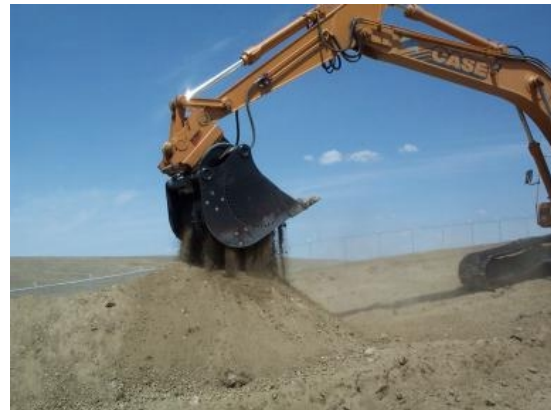
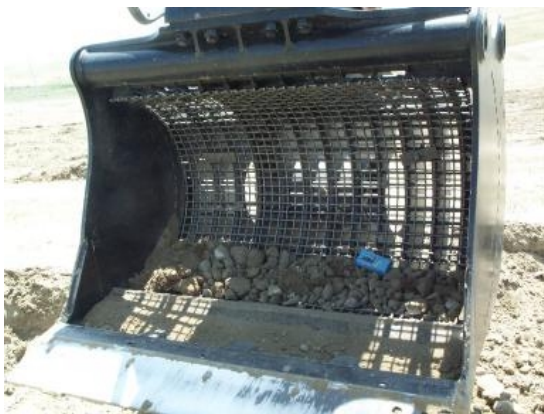
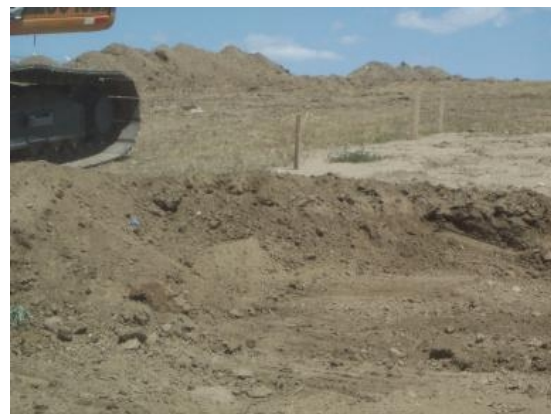
Figure A-15. VRL-8 Sorting Bucket Digging/Sifting as MAE

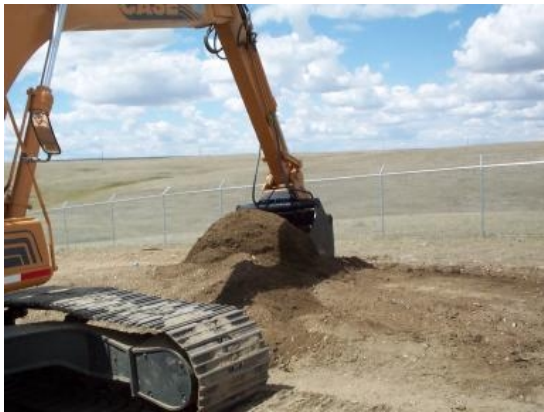
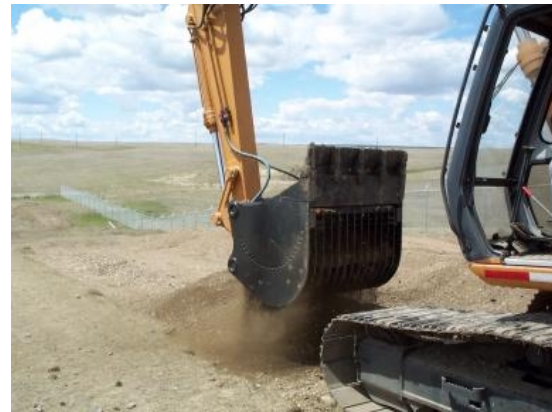
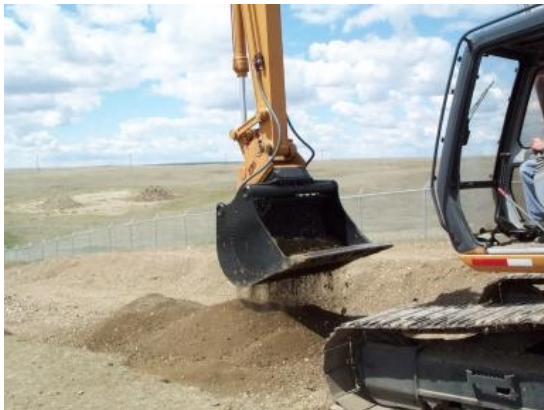
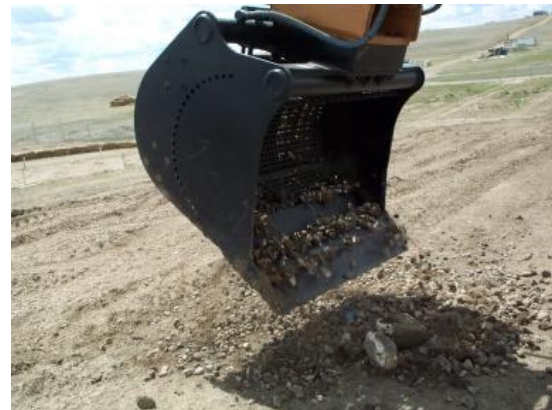
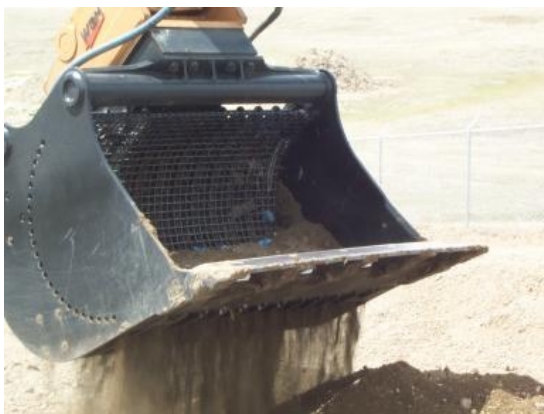
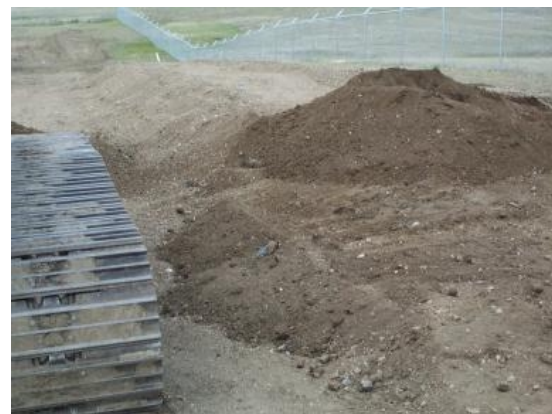
Figure A-21. VRL-8 Sorting Bucket Processing ProMac BDM48 Berm
